Call the Technical Resource Center from  
8am - 5pm PST: 800 394.9900

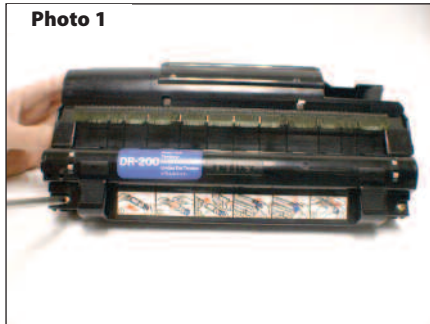
**JOHANNESBURG, S.A.**  
S.A. +27 11 974.6155  
FAX +27 11 974.3593

**Step 1**

Remove the two screws from the top of the drum unit.

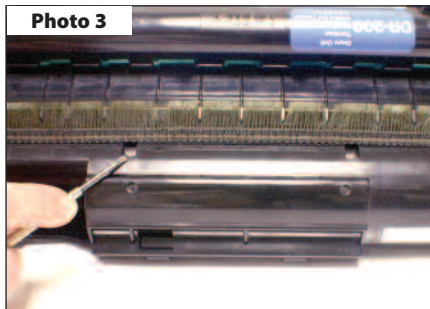
*(See Photo 2)*

**Step 3**

Locate the metal toner cover in the two slots on top of the cartridge.

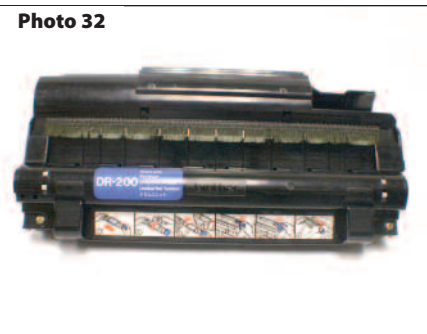
(See Photo 31)

**Step 30**

Place the cartridge cover on top of the cartridge and press down until the locking tabs hold the cover in place. Install the two screws that also hold the cover.

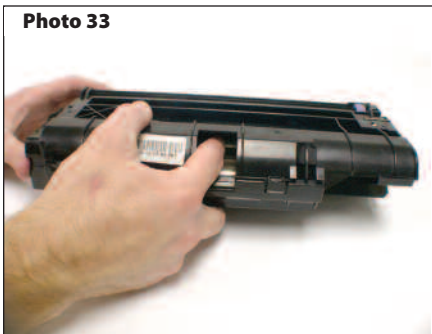
(See Photo 32)

**Step 31**

(See Photo 33)

Flip the cartridge upside down. Use your finger to slide the metal toner fill cover until the metal cover is just covering the toner fill opening.

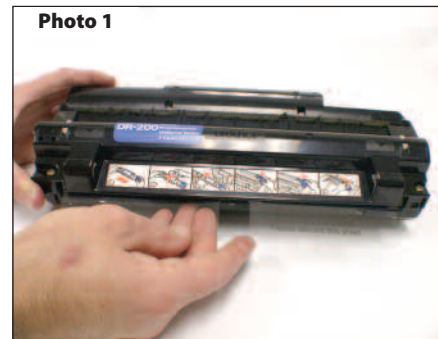
(See Photo 1)

Test cartridge.

**RESETTING THE DRUM COUNTER****Step 1**

Install the jagged end of the clear reset sheet into the cartridge between the drum and transfer roller.

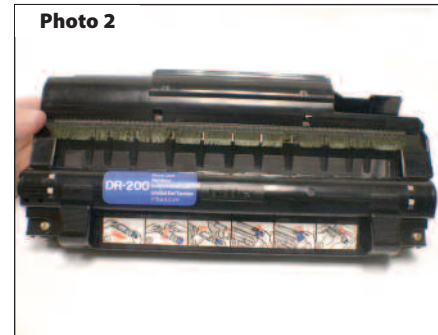
**NOTE:** Once the sheet is fed through the printer, the machine will reset the drum counter.

**Step 2**

Rotate the drum so the reset sheet is fed into the cartridge and the end of the sheet is flush with the end of the cartridge with the jagged end of the sheet sticking out the top of the cartridge. (See Photo 2)

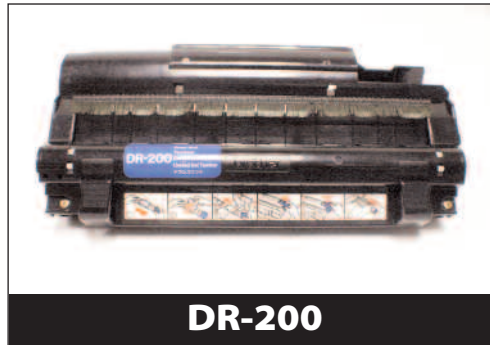
The Brother HL 720 engine was utilized in a wide variety of printer, fax and multi-function machines. It is now discontinued but a large number of these engines remain in the field. The Brother HL 720 is capable of printing at only 6 pages per minute at 600 x 600 dpi and consists of separate toner and drum units.
